## Comparison of cover meter and ground penetrating radar performance in structural health assessment: case studies

Professional paper

An essential step in the condition assessment of reinforced concrete structures and evaluation of the residual capacity is the determination of the arrangement and quantity of reinforcement as well as the geometry of the structural elements. The objective of this paper is to present the fundamentals in the application of two non-destructive methods, cover meter and ground penetrating radar, in the determination of the above structural features. A comparison of the two methods is presented and their capabilities, advantages and disadvantages are shown through nine case studies.

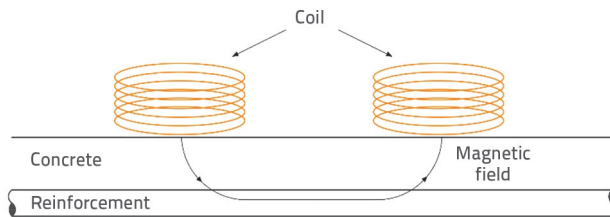
A cover meter is a device used to locate reinforcement in concrete. The principle of operation of a cover meter is shown in the following figure (Figure 2). Alternating current is induced in the coil, which generates an alternating magnetic field. The presence of reinforcing steel in the alternating magnetic field leads to the occurrence of eddy currents, which also form a magnetic field. This leads to a change in coil impedance, which serves as a basis for determining the thickness of the concrete cover and the diameter of the reinforcement [8].

Figure 2. Operating principle of cover meter

Inspection is performed by dragging the device along the line, which detects only the bars that are perpendicular to the drag line. Therefore, in most cases, inspection involves multiple line checks in two directions forming a network. Measurement accuracy is limited when reinforcement intersects with installed grids, anchors and other metals, when aggregates with magnetic properties are present in the concrete and when the concrete cover is thicker.

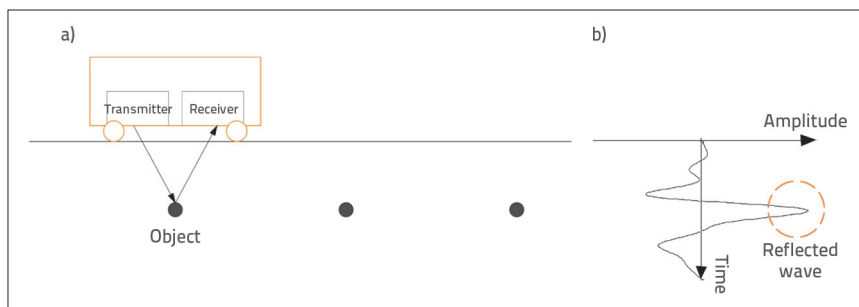
In GPR testing, scanning is performed along a defined line. During this scanning, waves are continuously transmitted into the material, and the reflected waves are registered by the receiving antenna. The two-dimensional reconstruction of the waves reflected along

Figure 3. a) GPR system, b) A-scan

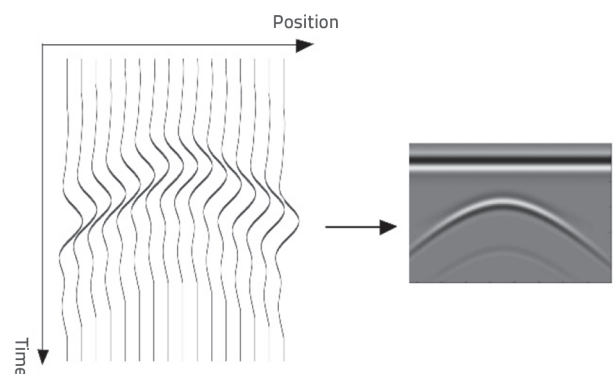
the depth following a defined line results in a radargram or B-scan. The horizontal axis indicates the GPR position in the area of interest, while the vertical axis indicates the two-way travel time (TWT) or depth (Figure 4). The radiated energy is approximately cone-shaped [9], so the waves are reflected before the device is directly over the object. The waves then have a slightly longer travel time to the receiver, so cylindrical objects, such as rebar, form a typical hyperbolic shape on the radargram when scanned perpendicular to their direction. The radargram is usually displayed in black and white, and the intensity is defined by the amplitude of the reflected wave. In the most common radargram types, the highest positive value of the amplitude corresponds to the areas displayed in white colour, while the highest negative value corresponds to the areas displayed in black colour.

Figure 4. Establishment of a radargram (right side) through association of A-scans

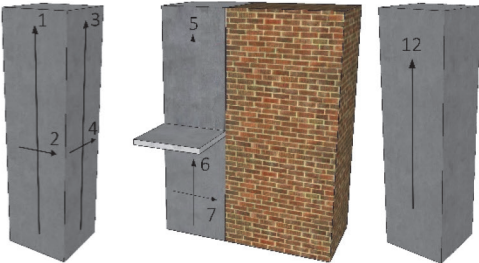
Table 2. Overview and designation of radargrams

Radargram designations and directions, as well as antenna frequencies corresponding to GPRs by which the radargram was obtained, are presented in Table 2. Examples used in this paper involve non-destructive testing of columns, wall, monolithic reinforced concrete slab, ribbed floor structures, massive vault structure, and wooden floor structure.

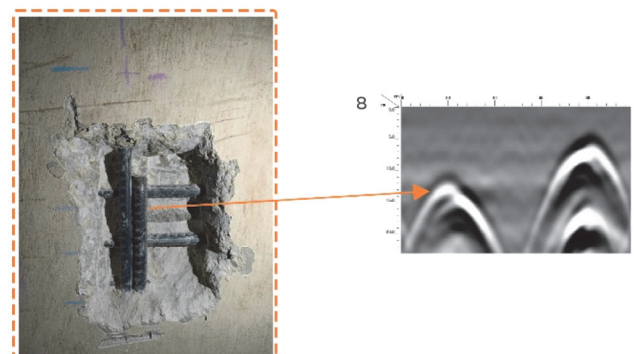
The determination of reinforcement overlap, which is a challenge for both devices, is shown in the following example. The cover meter cannot visualise this phenomenon, that is, it could suspect its presence based on the estimate of the reinforcement diameter, as in our case. In the case of the wall shown in Figure 7, the diameter of 40 mm was determined by the cover meter.

Figure 7. Opening concrete cover to confirm bar overlap

On the other hand, the GPR resolution is usually not sufficient to detect overlaps as two separate bars. In some cases, however, they can be detected as double-shifted hyperbolas, as was the case with the tested wall (Figure 7). This phenomenon does not

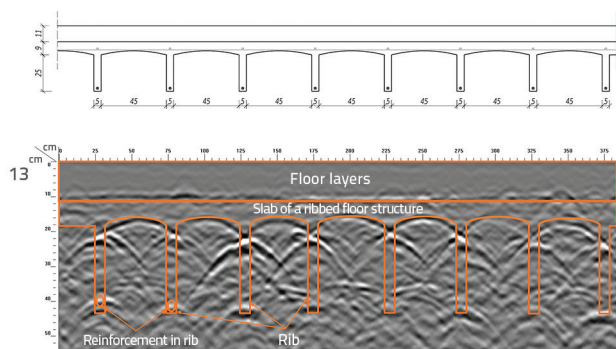
Figure 11. GPR reconstruction of ribbed floor structure based on radargram 13

when analysing the dimensions along the depth. A more accurate analysis of depth requires the selection of specific dielectric constants for each material if there is a significant difference between them. A typical feature of ribbed floor structures is repeatable negative reflections (concrete-air) corresponding to the bottom edges of the slab, where the axial spacing is equal to the spacing between the ribs. The following figures show examples of ribbed structures with curved (Figure 11) and flat (Figure 12) bottom edges of the slab.

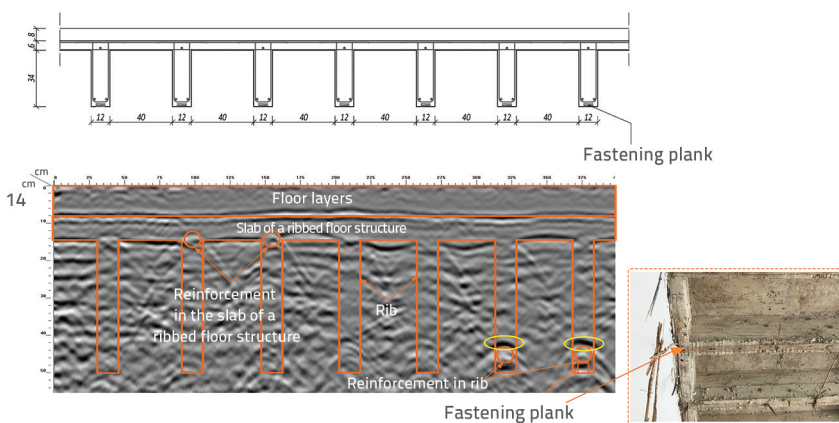
Figure 12. GPR reconstruction of ribbed floor structure based on radargram 14.

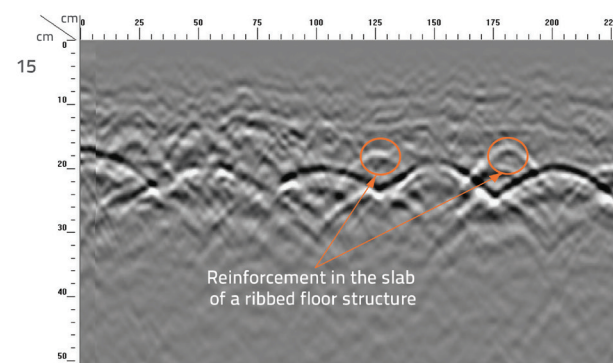
Figure 13. Determination of the presence of reinforcement in the slab of the ribbed floor structure

One of them can be seen in Figure 13, where hyperbolic marks over the positions corresponding to the rib positions confirm the presence of reinforcement in the slab. Similarly, the presence of distribution steel in the slab was confirmed by testing in the direction parallel to the spread of the ribs from the top of the floor structure. However, the spacing of this distribution steel differed from that indicated in the project documentation. In this case, the extended testing required testing of the slab from below as well as testing of the ribs. Based on the results of these

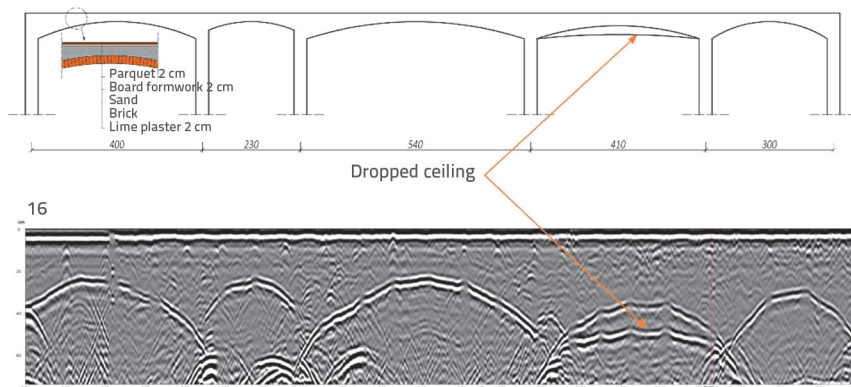
In the following case, the second-floor ceiling is a massive vaulted floor structure, with the vaults located between the walls of the basement. The ceiling of the second floor is a wooden floor structure with wooden beams in one direction. Using the radargram made perpendicular to the direction of propagation of the vaults, the span of the vaults and their height and thickness were estimated, as shown in Figure 14. It is assumed that the thicknesses of the floor layers correspond to the floors of masonry buildings constructed at

Figure 14. GPR-based estimation of span, height of vaults, and presence of dropped ceiling

the time of the construction of the studied building, as indicated in [21]. This radargram shows negative reflections corresponding to waves reflected from the bottom edge of the vault. It is assumed that the dielectric constants of sand and bricks are similar and that, according to equation (1), most of the energy is transferred during the transition from one material to the other. For this reason, no reflection can be observed at this point in radargram, but only the lower reflection, which corresponds to the joint reflection between brick, plaster and air.

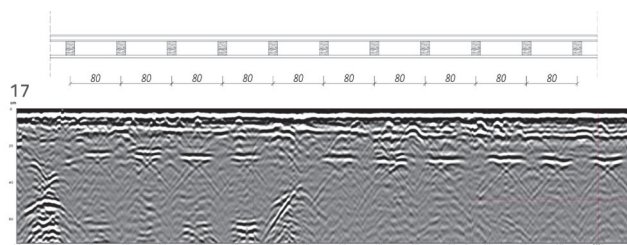
Figure 15. Determining distance between wooden joists.

In addition to estimating the span and height of vaults, it is also possible to determine the presence of dropped ceilings and estimate their height. The first reflection at the lower edge of the vault (brick, plaster - air) has a negative sign. However, the next reflection at the top edge of the dropped ceiling (air - dropped ceiling) has a positive sign. It is assumed that the resolution is not sufficient to detect the thickness of the dropped ceiling, so only the first reflected amplitude (air - dropped ceiling) is registered. When testing wooden floors, a large number of waves reflected in the upper zone (floor layers, top edge of the slab) does not allow clear identification of the beam geometry. For this reason, the distances of beams from wooden floors were determined using an indirect method based on the interaxial distance of reflections from the bottom edge. It should be noted that when testing wood structures whose dielectric constant of the material is close to the constant of air ( $\epsilon_r \approx -2$ ), the test can be improved by wetting the wood to increase the difference in dielectric constants of the materials and thus the strength of the reflection between wood and air.
